**FIELD IMPACT INSULATION TESTS**

**RIVER PLACE APARTMENTS, BRISBANE**

**TEST REPORT**

**TITLE** Field Impact Insulation Test  
DecoLine Pty Ltd product tests,  
Unit 286 – River Place Apartments  
82, Boundary Street,  
Brisbane City  
Test Report

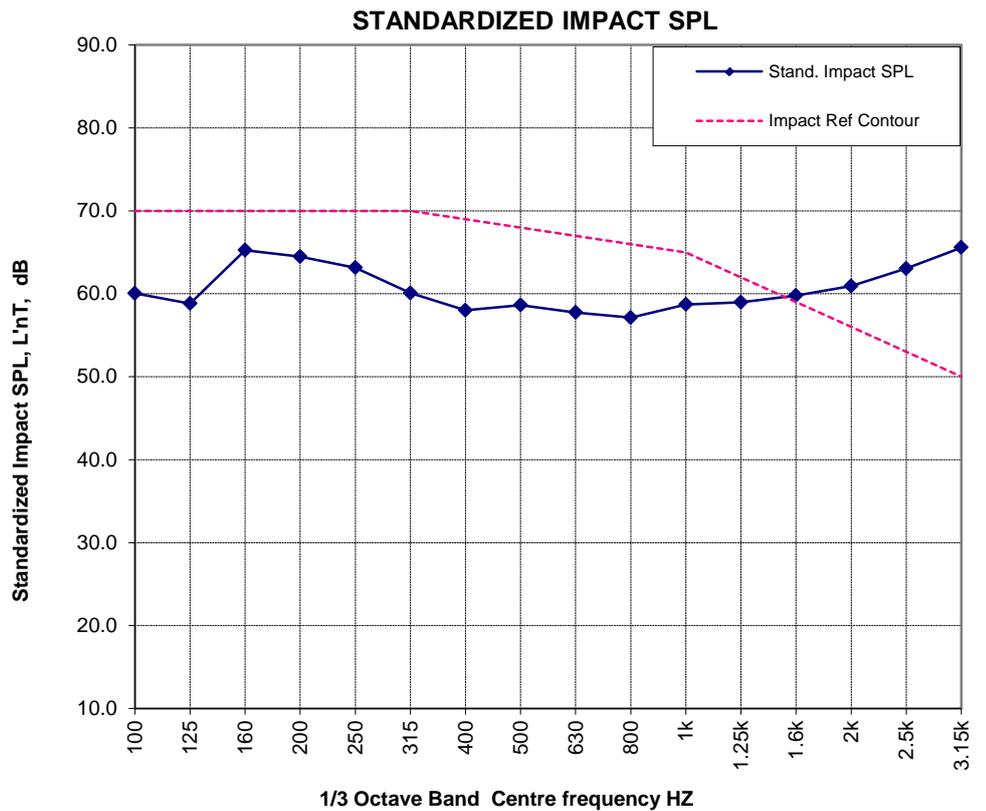
**Test 1 of 3**

**Bare Concrete Slab**

<b>DESCRIPTION OF FLOOR AND SPECIMEN</b>	<b>No. of Source posn:</b>	4
Floor: Bare Concrete Slab	<b>Mic. posn:</b>	4 sweeps
Product:	<b>RT meas:</b>	6 Imp.
Adhesive:	<b>SLM:</b>	Nor 140
Ceiling: Plasterboard		
Slab: 200mm Concrete slab

<b>Weighted Standardized Impact SPL</b>	<b>L'nT,w</b>	<b>68</b>	ISO 16283-2:2015 & 717-2:1996
Results standardized to a RT of 0.5 seconds			
Impact Insulation Class			ASTM E1007-97 & E989-89

Centre Frequency Hz	Stand. Impact SPL dB	Impact Ref Contour dB	Deficiencies dB
100	60.1	70	
125	58.8	70	
160	65.3	70	
200	64.5	70	
250	63.1	70	
315	60.1	70	
400	58.0	69	
500	58.6	68	
630	57.8	67	
800	57.1	66	
1k	58.7	65	
1.25k	59.0	62	
1.6k	59.8	59	0.8
2k	60.9	56	4.9
2.5k	63.1	53	10.1
3.15k	65.6	50	15.6
<b>Total</b>

L'nT,w	68	31.4
--------	----	------

Test System	L'nT,w
Test 1 – Concrete slab with plasterboard ceiling	68
Test 2 – 5mm Decoline SkyLine vinyl plank	61
Test 3 – 5mm Decoline SkyLine vinyl plank + 3mm Dunlop Advantage 3	53

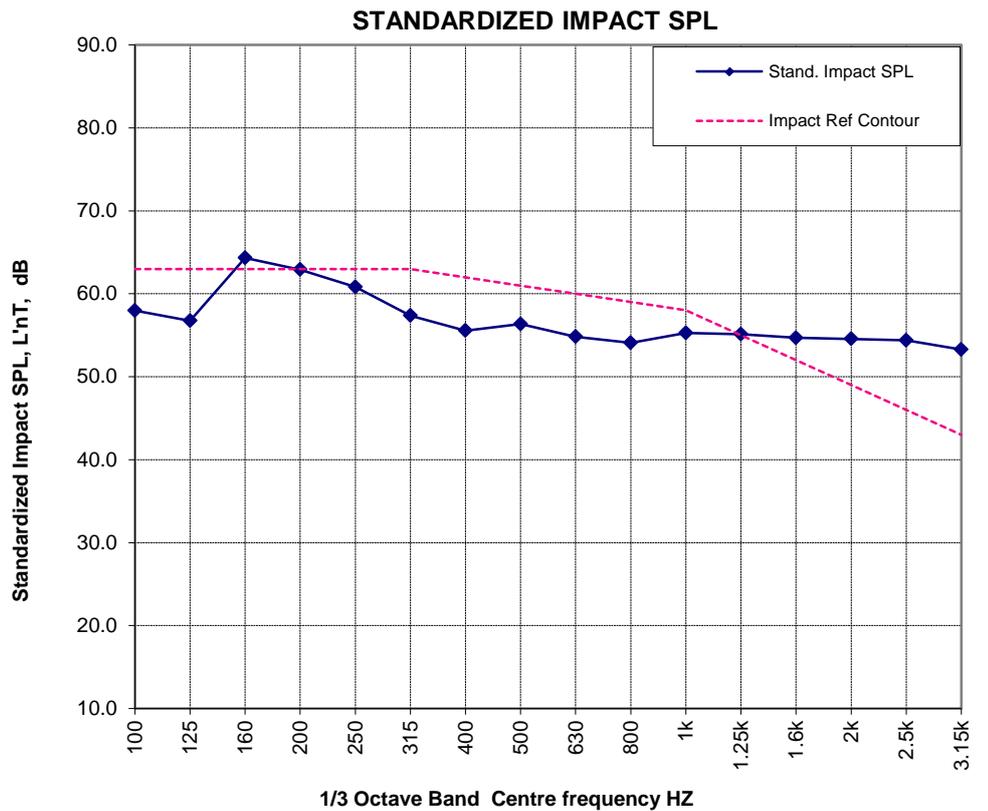
**Test 2 of 3**

**5mm DecoLine Vinyl Sample**

<b>DESCRIPTION OF FLOOR AND SPECIMEN</b>	<b>No. of Source posn:</b>	4
Floor: 5mm DecoLine Vinyl Sample	<b>Mic. posn:</b>	4 sweeps
Product:	<b>RT meas:</b>	6 Imp.
Adhesive: Loose laid	<b>SLM:</b>	Nor 140
Ceiling: Plasterboard		
Slab: 200mm Concrete slab

<b>Weighted Standardized Impact SPL</b>	<b>L'nT,w</b>	<b>61</b>	ISO 16283-2:2015 & 717-2:1996
Results standardized to a RT of 0.5 seconds			
Impact Insulation Class			ASTM E1007-97 & E989-89

Centre Frequency Hz	Stand. Impact SPL dB	Impact Ref Contour dB	Deficiencies dB
100	58.0	63	
125	56.8	63	
160	64.3	63	1.3
200	62.9	63	
250	60.8	63	
315	57.4	63	
400	55.6	62	
500	56.4	61	
630	54.8	60	
800	54.1	59	
1k	55.3	58	
1.25k	55.1	55	0.1
1.6k	54.7	52	2.7
2k	54.6	49	5.6
2.5k	54.4	46	8.4
3.15k	53.3	43	10.3
<b>Total</b>

L'nT,w	61	28.4
--------	----	------

Flooring types	$\Delta L'nT,w$ Reduction
1. 5mm Decoline SkyLine vinyl plank	7
2. 5mm Decoline SkyLine vinyl plank + 3mm Dunlop Advantage 3	15

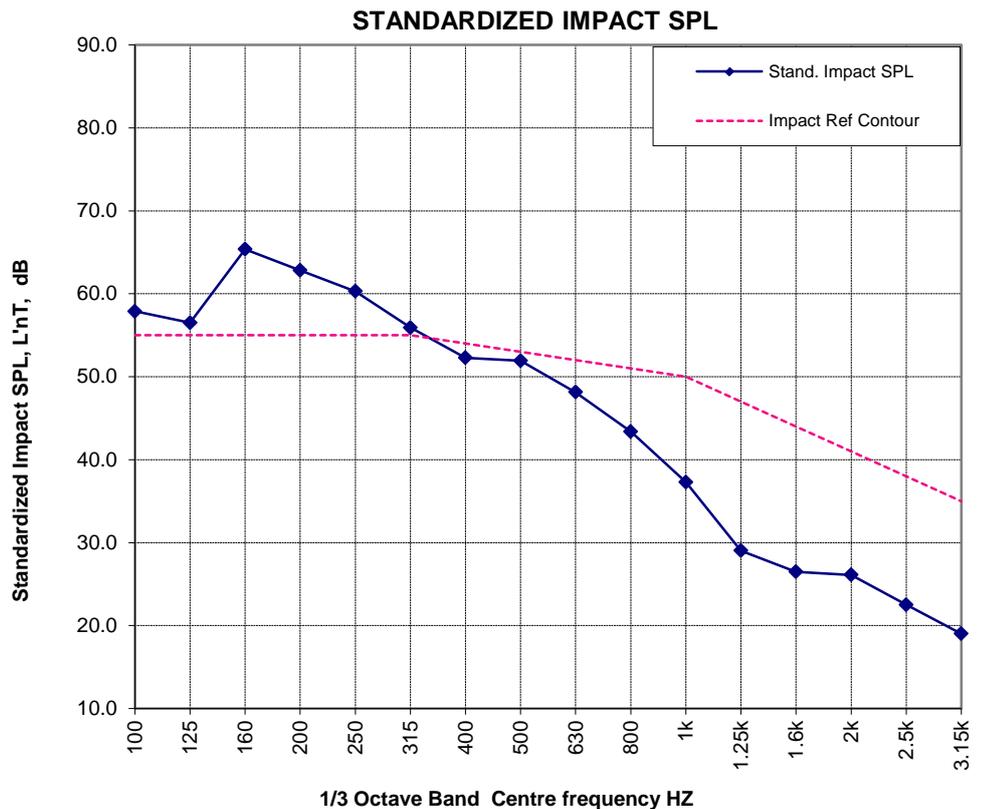
Test 3 of 3

5mm DecoLine Vinyl Sample

3mm Dunlop Advantage 3 underlay

<b>DESCRIPTION OF FLOOR AND SPECIMEN</b>	<b>No. of Source posn:</b>	2	
Floor:	5mm DecoLine Vinyl Sample	<b>Mic. posn:</b>	2 sweeps
Product:	3mm Dunlop Advantage 3 underlay	<b>RT meas:</b>	6 Imp.
Adhesive:	Loose laid	<b>SLM:</b>	Nor 140
Ceiling:	Plasterboard		
Slab:	200mm Concrete slab

<b>Weighted Standardized Impact SPL</b>	<b>L'nT,w</b>	<b>53</b>	ISO 16283-2:2015 & 717-2:1996
Results standardized to a RT of 0.5 seconds

Centre Frequency Hz	Stand. Impact SPL dB	Impact Ref Contour dB	Deficiencies dB
100	57.9	55	2.9
125	56.5	55	1.5
160	65.4	55	10.4
200	62.8	55	7.8
250	60.3	55	5.3
315	55.9	55	0.9
400	52.3	54	
500	51.9	53	
630	48.1	52	
800	43.4	51	
1k	37.3	50	
1.25k	<	47	
1.6k	<	44	
2k	<	41	
2.5k	<	38	
3.15k	<	35	
<b>Total</b>

L'nT,w 53 28.8
